This is to certify that from 25 to 27 June, 2012, MINUSTAH Military Engineers carried out a pilot project using the AGGREBIND © product for surface stabilization. The test was done on a stretch of dirt road (100 meters long by six meters wide) on Tabarre 52, Port-au-Prince, Haiti. Mr. Robert Friedman, President and representative of AGGREBIND ©, was present to supervise and guide the test by MINUSTAH.

Tabarre Road Test Report to
MINUSTAH HAITI

ENGINEERING FINAL REPORT – IWO NR 358/U-8 Ops

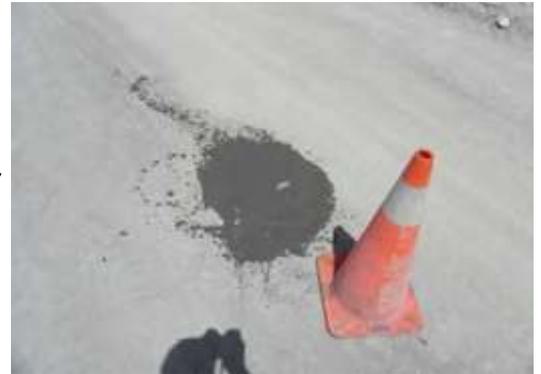
On Side One the distribution of the AggreBind:Water mixture was completely disbursed in five separate passes, then disc hoe mixed in, vibro compacted and top sealed. On Side Two we disc hoe mixed after each release of the AggreBind:Water mixture and then disc hoe mixed in, vibro compacted and top sealed. The sequence of 5 releases and 5 mixes is better than a full disbursment followed by mixing. The scars or patches caused by the grader were filled in with a slurry mix of the soil and AggreBind.

These patches set very quickly. The patched areas were barely discernible from the rest of the road.

***See the attached protocol for patching.
AggreBind will bind to asphalt roads and cement roads.***

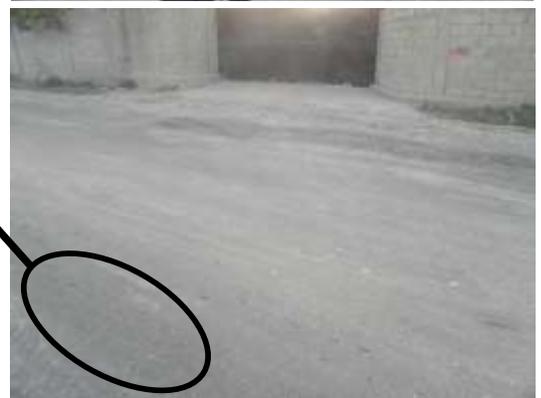
One of the patched areas

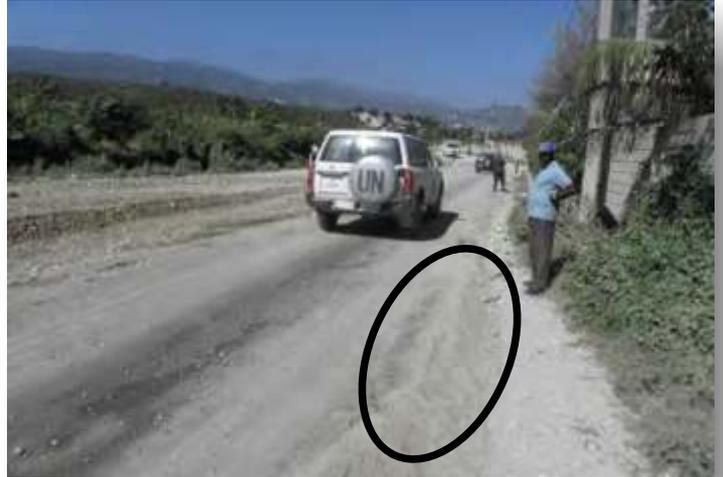
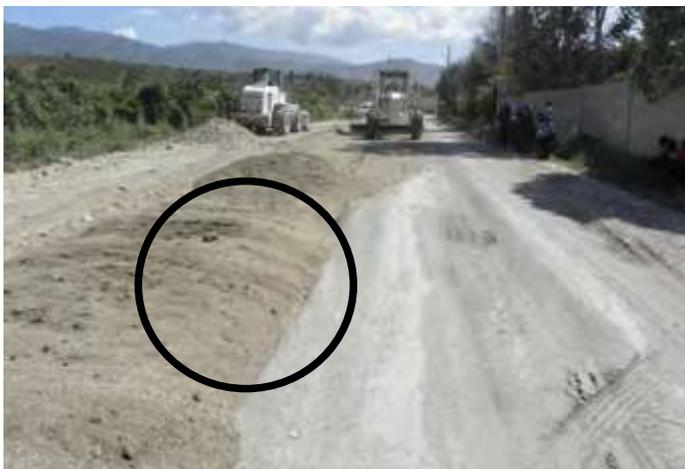
Grading of Side Two tore up sections of Side One, along the middle.

The spillage into the road from the shoulders caused markings and disturbance to the freshly rolled and coated surface of the road. These “scars” can be avoided in the future with a clean work site from shoulder-to-shoulder.

When prepared materials are going to be used, excavate the full road before processing. Close one side, excavate, then open and do the same on the second side.

This will prevent the spillage of the excavated materials on to the finished side.

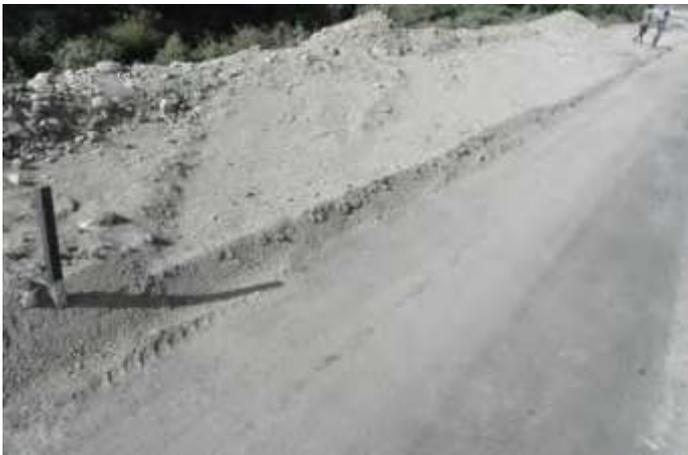
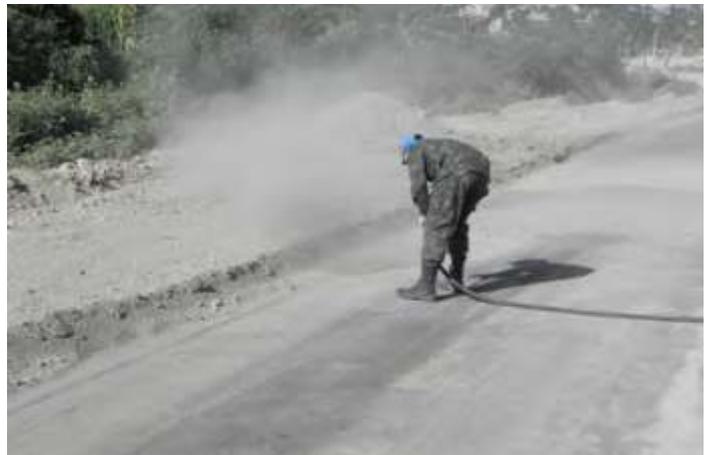
Piles left on the sides caused unnecessary work. These were finally removed at the end of the project. These piles should have been removed at the beginning so that there would have been clean working areas.

If the road sides were sloped (pitched outward) it would reduce or eliminate the surface water on the road after heavy rainstorms.

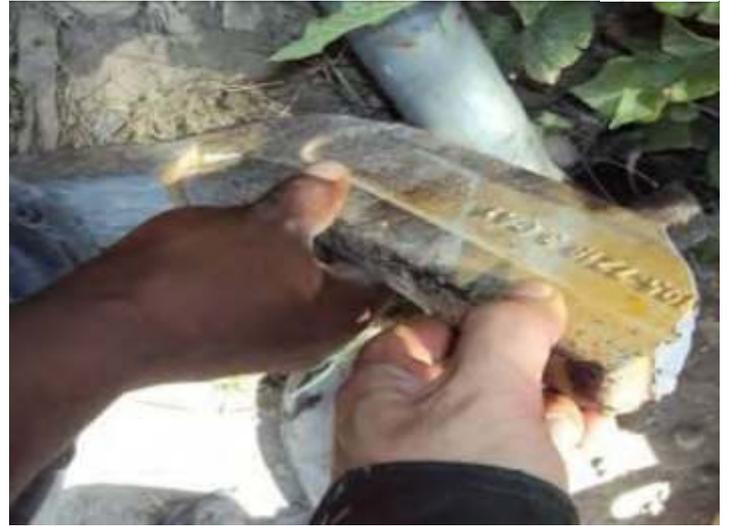
The work ended at approximately 09:30 pm. It is important to highlight that during the scarification, a tooth of the scarifier (grader) broke due to the abundant presence of hard rocks and hand Stones at the site. Also, as an adversity and still during scarification, it is important to mention that a water pipe which supplies the HNP facility was broken. All the necessary repairs were done by BRAENGCOY troops and thus they retard the accomplishment of the schedule set for the day.

Picture 04: Grader broken tooth

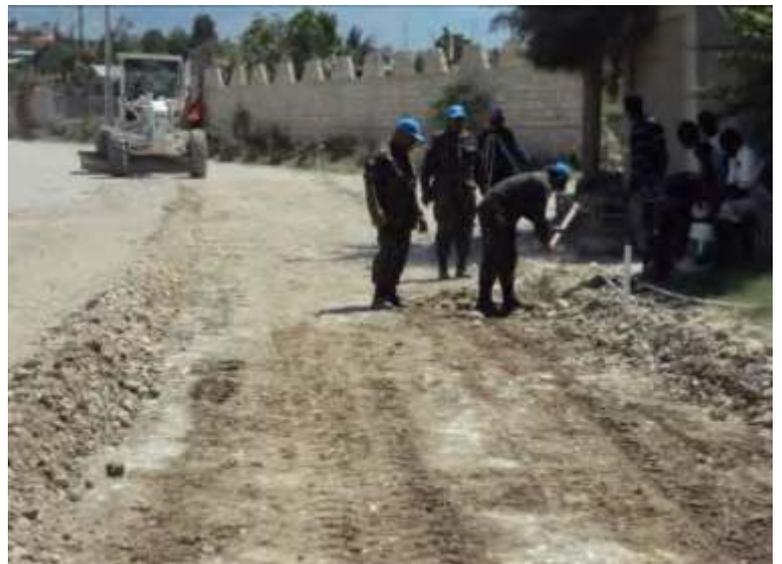
Breaking the water pipe which is under the road caused an excessive humidification of the material deposited. Even under a blazing sun, it is possible to state that the excess of water was responsible for the imperfections on the road. Moreover, the intense traffic of vehicles coming and going out of a residence occupied by the HNP also made it difficult the adequate execution of works. It is still important to mention that the intense traffic of trucks full of ramblair, in some occasions, left material on the road and drivers disrespected BRAENGCOY traffic signs as well.

Picture 06: Repair of broken pipe.

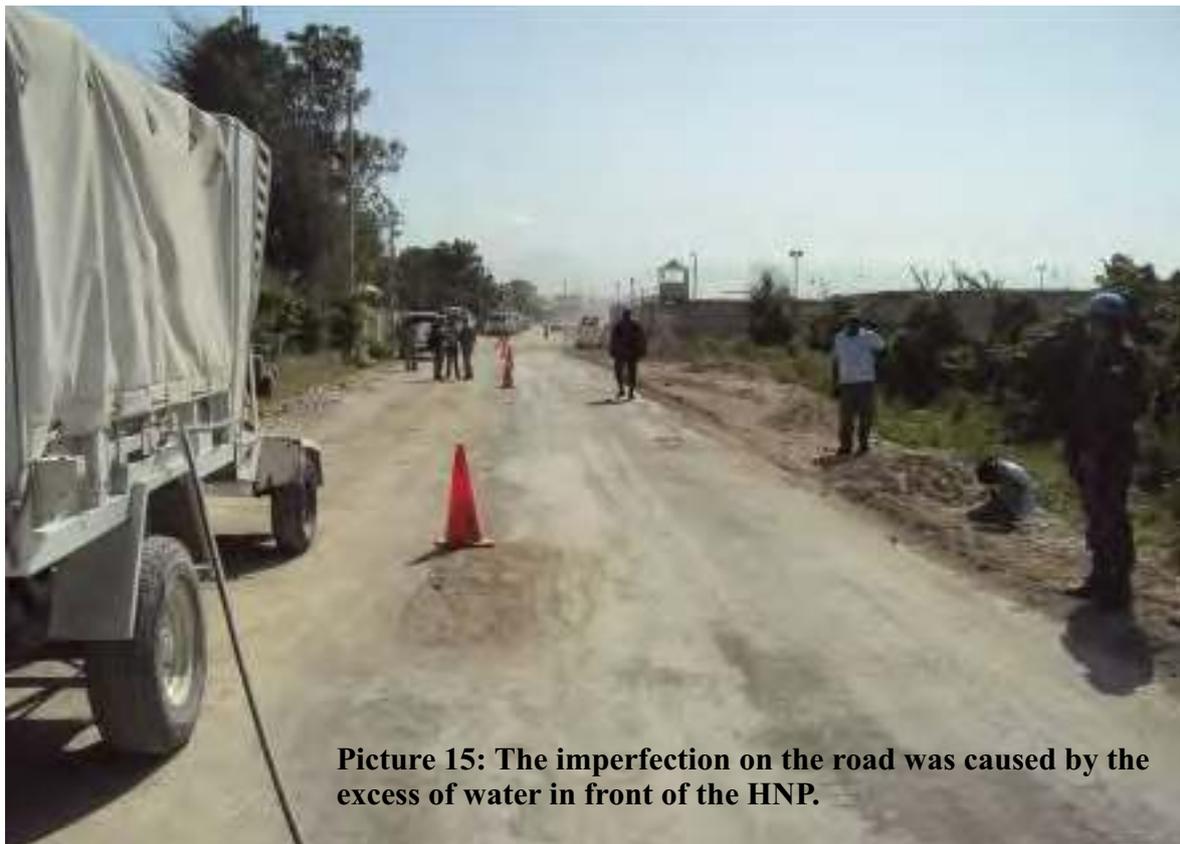
There is an area that bothers me. It is in the middle of the road and across from the driveway entrance to the National Police. Slurry mix was placed in there. It is possible that this patched section was opened up too soon. (The crew needed to leave at 12:30PM. They did not want to leave cones on the road feeling the cones would be stolen. I did not insist that they post someone on the spot for two hours more.) The remedy is to make another AggreBind slurry (soil/sand & AggreBind) and place it in the area. I would continue to observe that small area to confirm that the surface was damaged by the grader and that there is no moving water underneath the road. (This is where the water pipe leaked and was replaced.)

Picture 15: The imperfection on the road was caused by the excess of water in front of the HNP.

In order to best support the decision, it is recommended that the performance of the paved area be analyzed as time goes by, mainly in relation to the following aspects: resistance to intense traffic and to weather conditions (esp. downpours).
