UN MINUSTAH HAITI
Tabarre 52 Test Road at the National Police Unit
Before

**Tabarre Road Test Report to
MINUSTAH HAITI**

ENGINEERING FINAL REPORT – IWO NR 358/U-8 Ops

Data	18 June 2012
Mission	AggreBind Test
Document	IWO NR 358/U-8 Ops
Location	Tabarre 52 Street (next to Charlie Camp)
Coordinates	N18° 33' 21.25" N, W72° 15' 13.58"
Start	25 June 12
End	27 June 12
Deployed troops	17 troops
Used equipment	01 Loader, 01 Skid steer, 01 roller, 01 grader, 01 light tractor, 01 Plough trailer and 01 Air compressor
Used vehicles	01 Water truck, 02 Dump truck, 01 Truck tractor, 01 low bed and 01 ¾ ton Marrua Jeep
Used material	Sand and AggreBind.
Main activities	Leveling and Compacting
Considerations	According to letter “e”, number 2

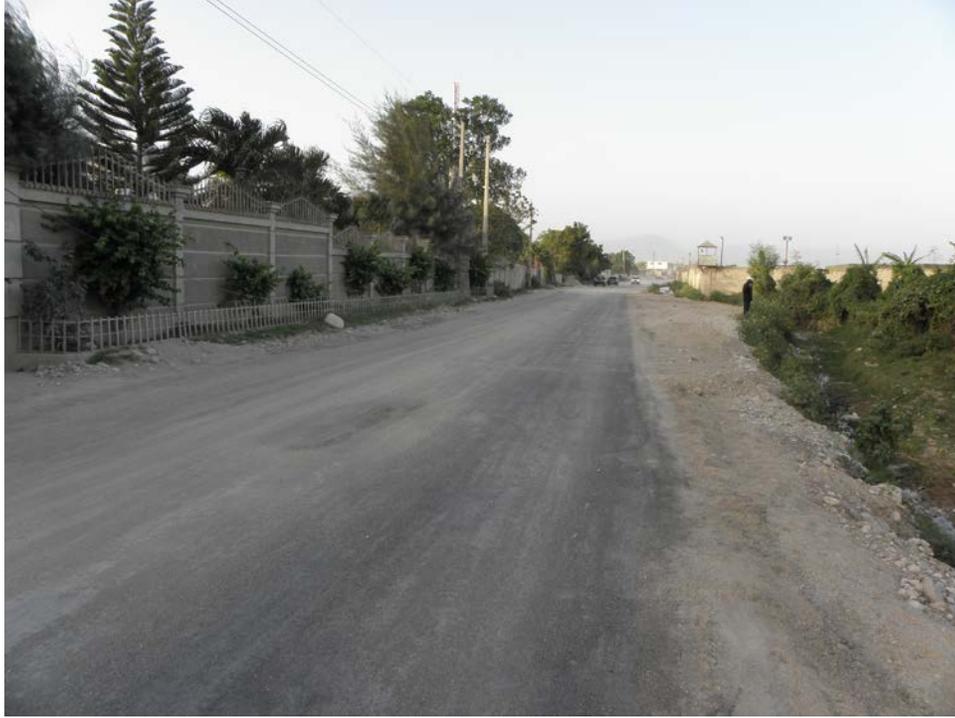
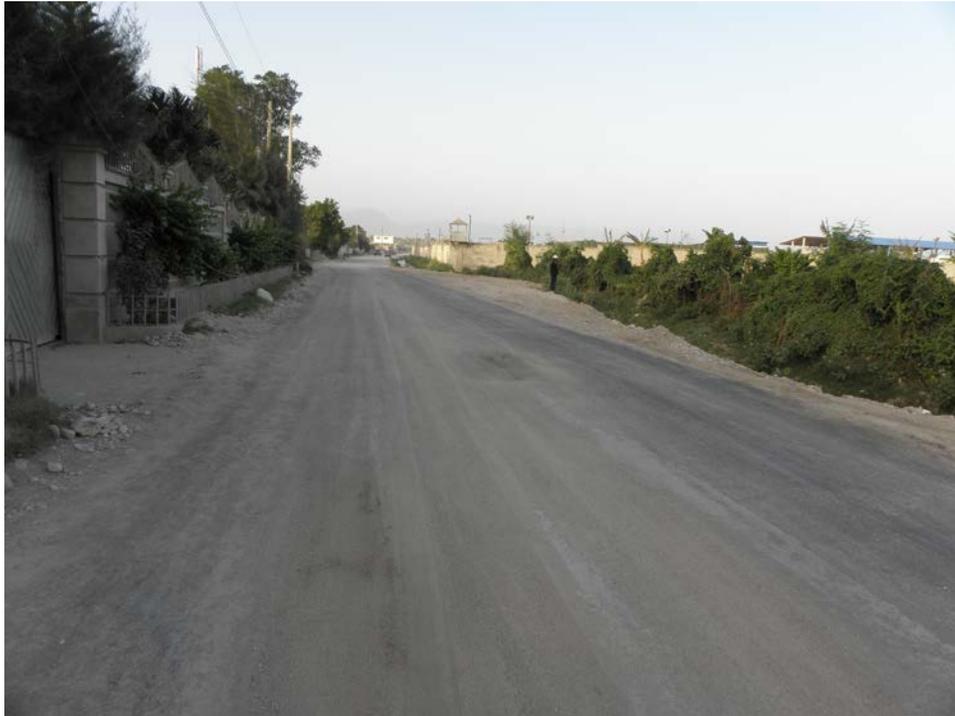
7:00 PM, June 27, 2012

Side One, the inner side, was opened within two hours of completion.
Side Two, the outer side, was opened after six hours of completion.

AggreBind is a cross-linking styrene acrylic polymer that gets progressively stronger and more resilient with the passage of time. The maximize time for full compression strength is 28 days. The process of curing is by the evaporation of the moisture and the chemical action of the cross linking. **Roads are opened within two hours, as a matter of necessity, with no affect to the curing.** When situations permit, it is good to allow more time before opening the road.

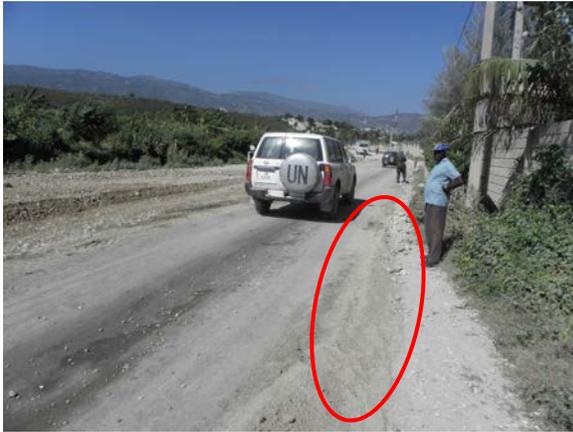
Soil, rocks and stones migrated into the road from passing trucks (wider than cars) and kicked these loose stones into the road. The shoulders should have been cleaned of debris. (This was not seen at night when Side One was being finished.)

When prepared materials are going to be used, excavate the full road before processing. Close one side, excavate, then open and do the same on the second side.

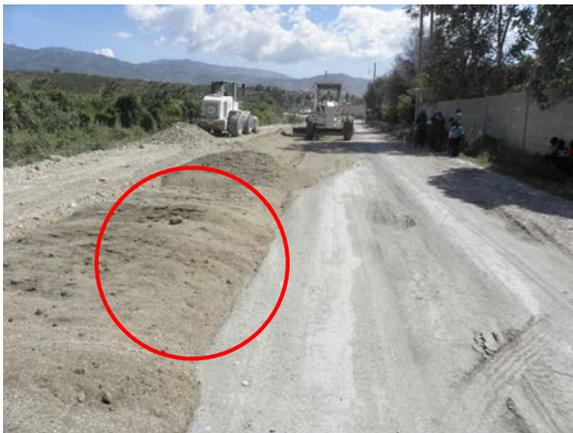
This will prevent the spillage of the excavated materials on to the finished side. Grading of Side Two tore up sections of Side One, along the middle.

The spillage into the road from the shoulders caused markings and disturbance to the freshly rolled and coated surface of the road. These “scars” can be avoided in the future with a clean work site from shoulder-to-shoulder.

Further, AggreBind in white (dries clear) can be used on the shoulders to spray the loose material.

- This would eliminate the ambient dust and dirt from rolling onto the roads.
- Would make the road safer and healthier for both motorists and pedestrians.
- It would also reduce vehicle maintenance costs.

If the road sides were sloped (pitched outward) it would reduce or eliminate the surface water on the road after heavy rainstorms.

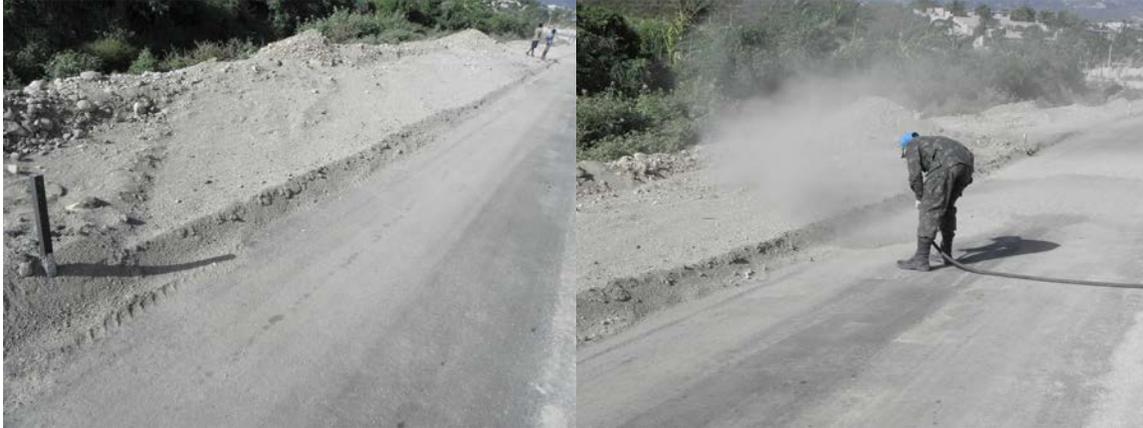
Piles left on the sides caused unnecessary work. These were finally removed at the end of the project. These piles should have been removed at the beginning so that there would have been clean working areas.

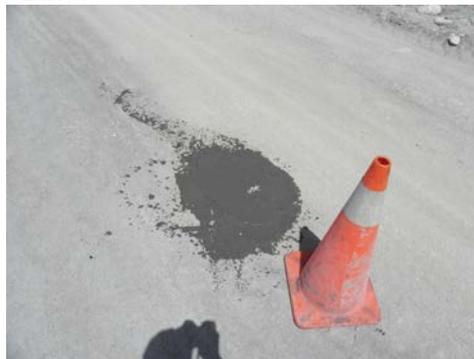
On Side One the distribution of the AggreBind:Water mixture was completely disbursed in five separate passes, then disc hoe mixed in, vibro compacted and top sealed. On Side Two we disc hoe mixed after each release of the AggreBind:Water mixture and then disc hoe mixed in, vibro compacted and top sealed. The sequence of 5 releases and 5 mixes is better than a full disbursal followed by mixing. The scars or patches caused by the grader were filled in with a slurry mix of the soil and AggreBind.

These patches set very quickly. The patched areas were barely discernible from the rest of the road.

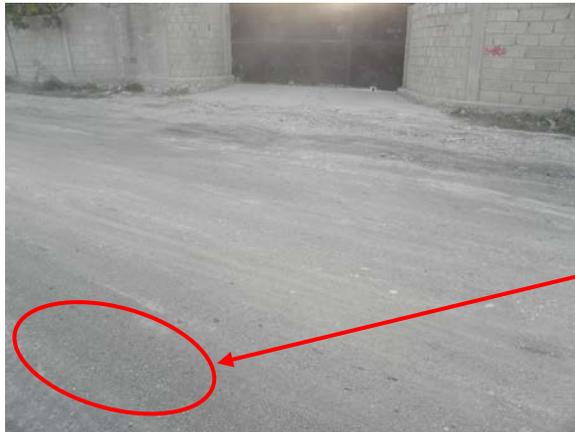
One of the
patched areas

See the attached protocol for patching. AggreBind will bind to asphalt roads and cement roads.

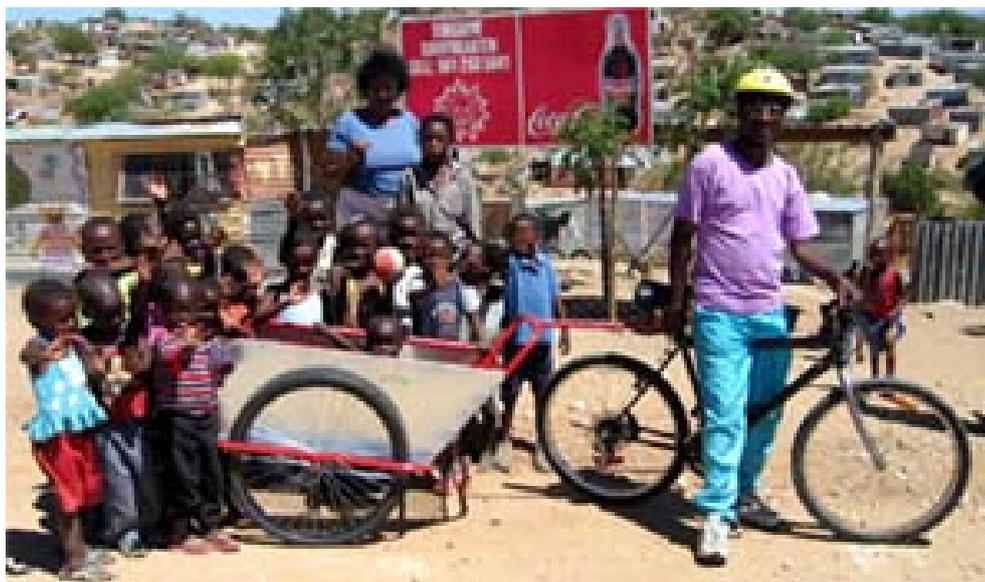
'Bike Bakki' rural road pothole repairs plus dust and erosion control services.

Equipment: Pothole repairs.

- Basic equipment:
 - Pick, Shovel, Watering Can, Hand Tamper, Road repair signs and 50 ltrs Aggrebind mixed with 150 ltrs water.
- Procedure:
 - Break the soil to form a square, 15cm deep and slightly larger than the damaged area. Spray the surfaces of the hole with the Aggrebind/water mixture. Obtain some additional soil from the areas at the side of the road and add the Aggrebind/water before mixing thoroughly. Do the 'squeeze in the hand test' to ensure that the moisture level is correct.
- Fill the exposed pothole and compact thoroughly with the hand tamper.
- Spray the compacted surface with the Aggrebind/water mixture ensuring that you spray about one hand width past the edge of the repaired pothole.
- Do not carry out repairs if rain is expected within 2 hours.

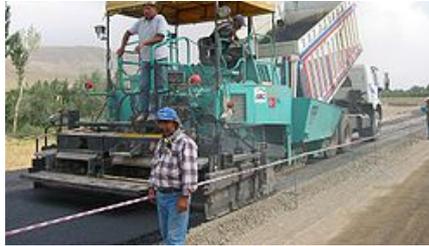
Road base with a thin layer of Asphalt

Machine laying asphalt concrete, fed from a dump truck.

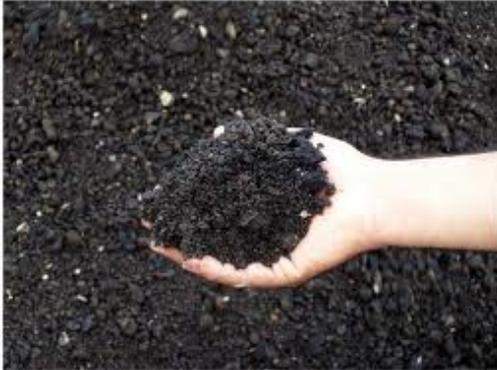
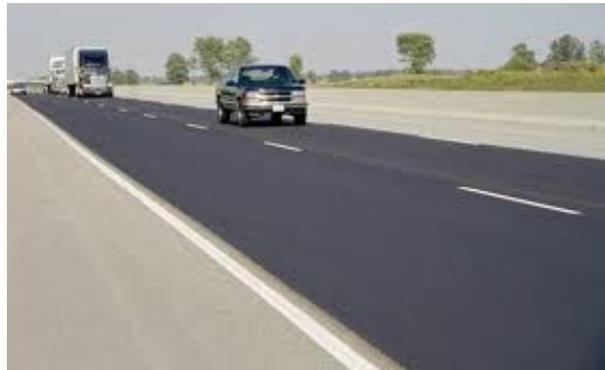
Procedures:

1. Thoroughly crush the surface to the required depth.
2. Check that the base below the crushed Asphalt is structurally sound. Repair and re-compact the base if necessary.
3. Carry out a sieve analysis of the crushed Asphalt.
4. Add, and mix in fines (passing through a 0.063 sieve) if necessary, to ensure that the fines content is 35%+ of the total volume to be stabilised.
NOTE: Fines can be any locally available material: Soil, Sand, Mine waste, etc.
5. Spray the area with a mixture of 1 part AggreBind mixed with 3 parts water at a rate of 1.5ltrs per sq mtr per 50mm depth of Asphalt.
6. Grade and profile the surface.
7. Compact with a smooth drum road compactor.
8. Spray the surface again with a mixture of 1 part Aggrebind mixed with 3 parts water at a rate of 1 ltr per sq mtr.
9. Do not install if rain or frost is imminent.
10. Open the road to traffic after 2 hours

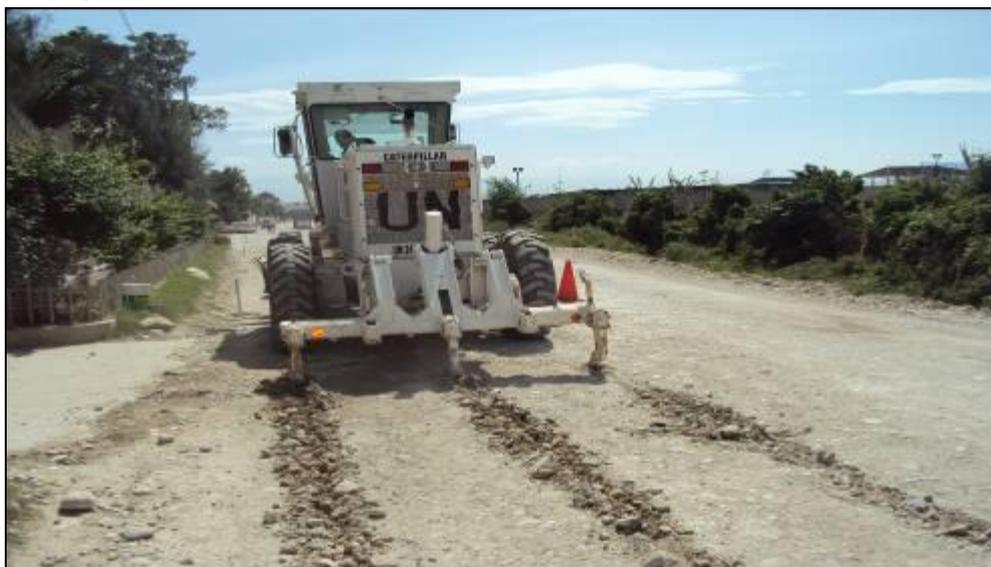
Picture 03: Initial situation and scarification.

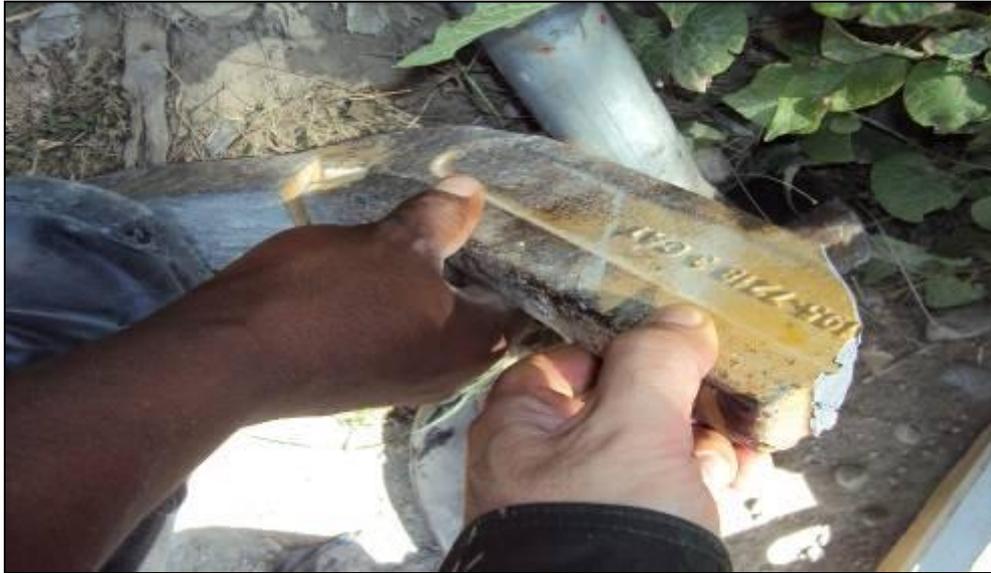
The work ended at approximately 09:30 pm. It is important to highlight that during the scarification, a tooth of the scarifier (grader) broke due to the abundant presence of hard rocks and hand Stones at the site. Also, as an adversity and still during scarification, it is important to mention that a water pipe which supplies the HNP facility was broken. All the necessary repairs were done by BRAENGCOY troops and thus they retard the accomplishment of the schedule set for the day.

Picture 04: Grader broken tooth

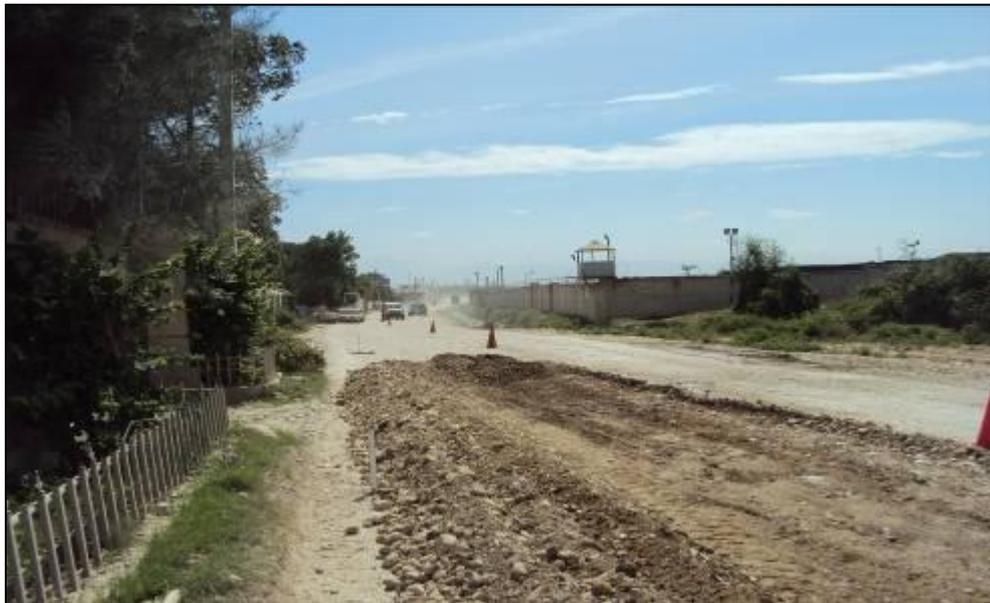
The lane stretch was set (100 meters long and 03 meters wide) by using sticks every 20 meters, and it was also set a cut level of 15 cm from the natural ground. The cut and the consequently disposal of material are due to the recommendation of the manufacturer to exclude stones whose diameter is over 2.0 cm (these particles are abundant at the site chosen to test the product) from the mixture. Either the cut and disposal of material, or the application of (gravel) sand had been defined by the recce determined by IWO 342 U8/Ops.

Picture 05: Cut and removal of 15 cm of natural soil.

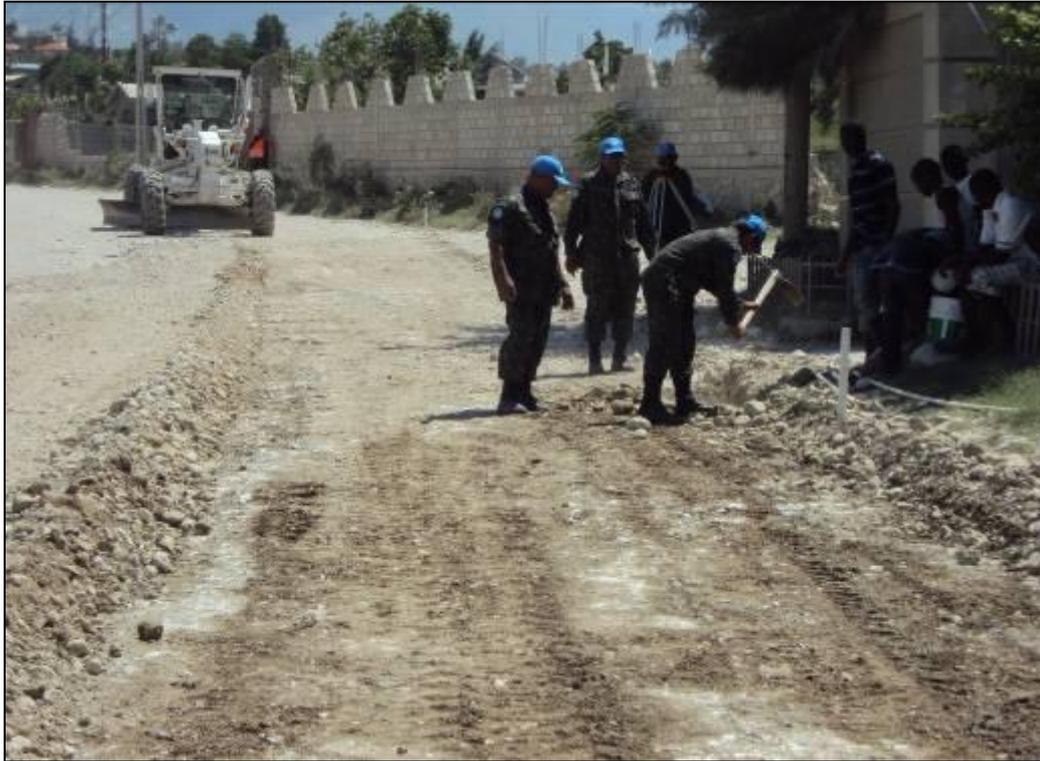
Picture 06: Repair of broken pipe.

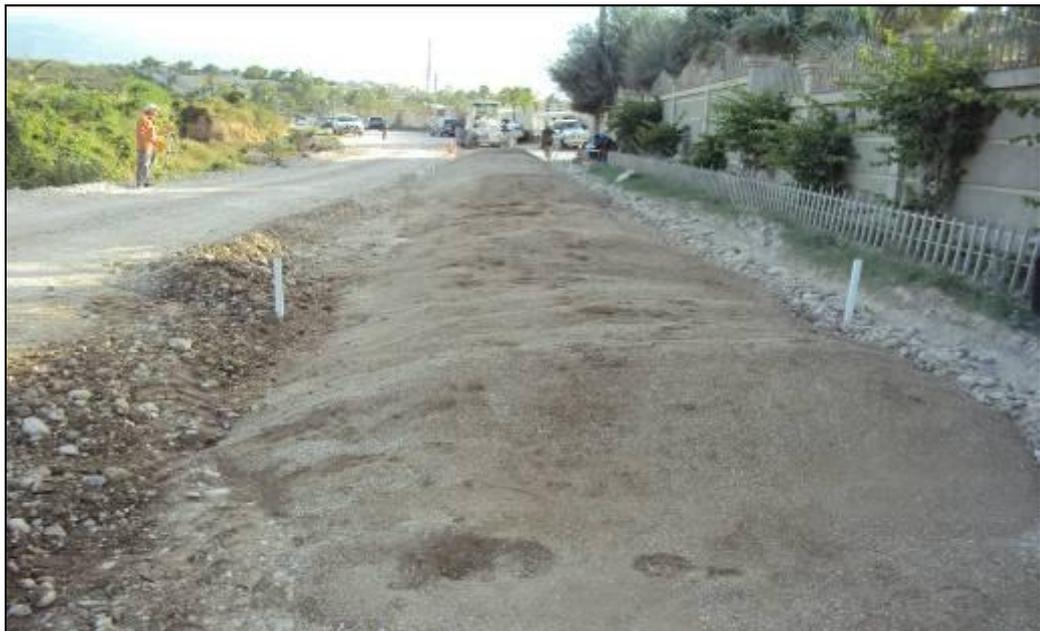
Picture 07: Sand application

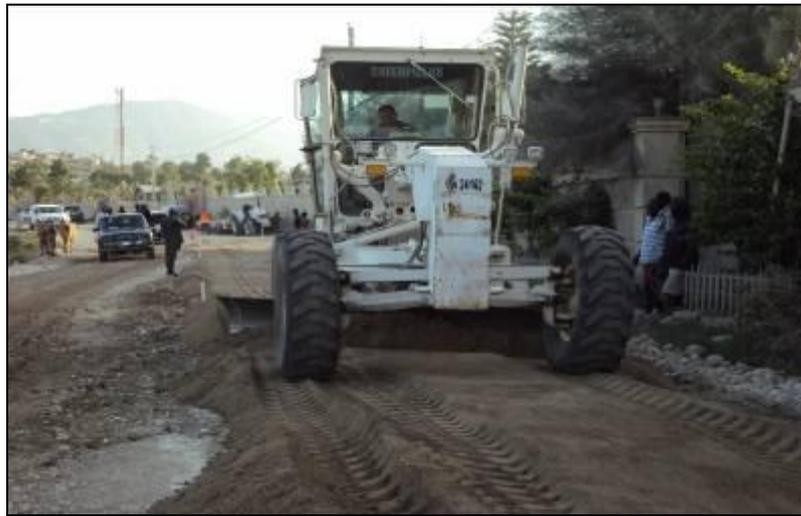
Picture 08: Ground leveling.

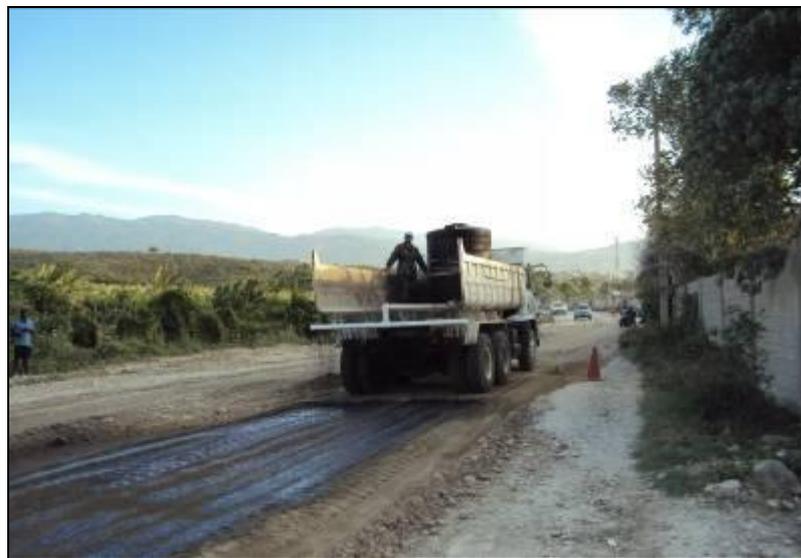
Picture 09: Application of the mixture - Aggrebind: water.

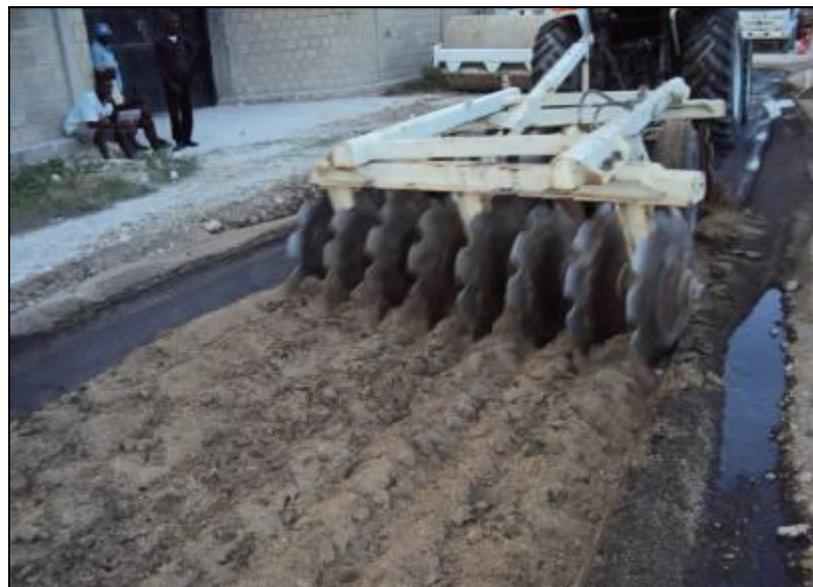
After finishing the application of the total quantity of the mixture on the road, the mixture (substance-soil) was homogenized by the plough trailer. Once more, the material was compacted by using a roller.

Picture 10: Homogenization.

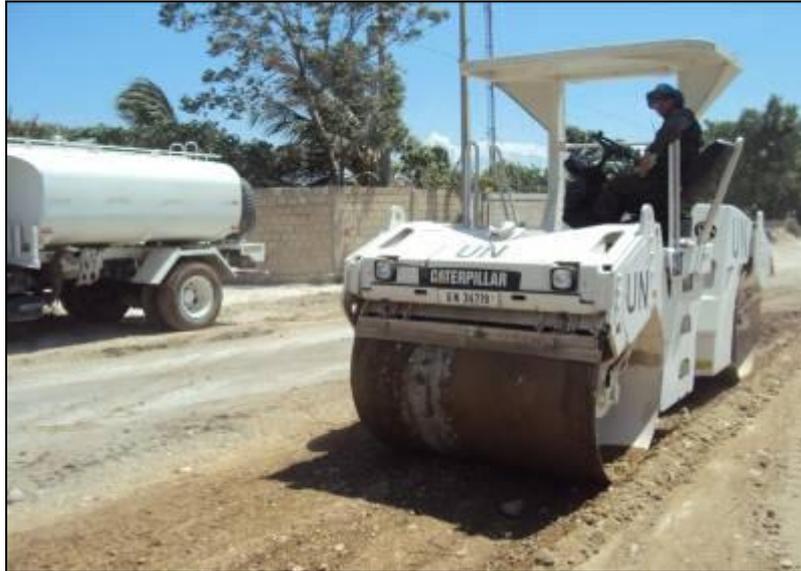
Picture 11: Compacting

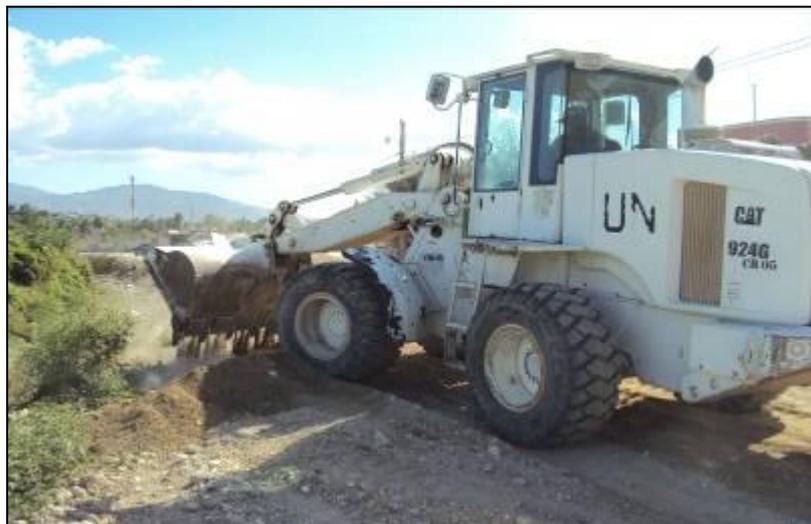
Picture 12: Cleaning the road sides.

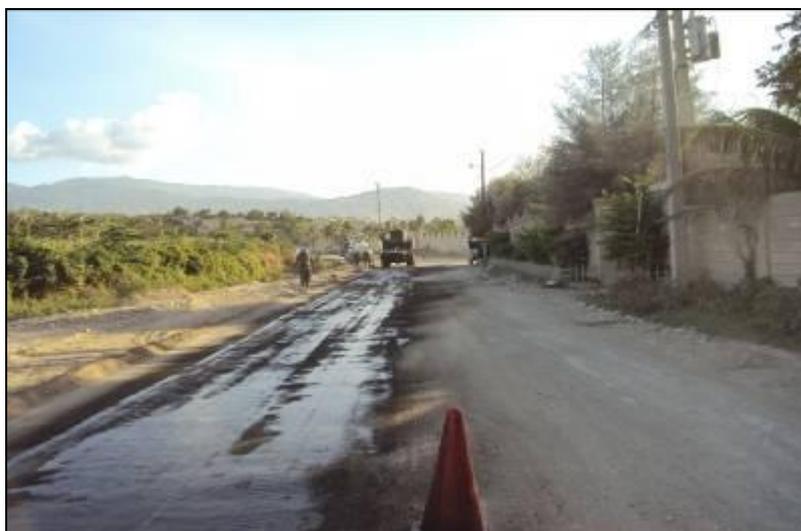
Finally, a sealing mixture was applied to the proportion of 1:3 (AggreBind: water).

Picture 13: Application of the sealing layer

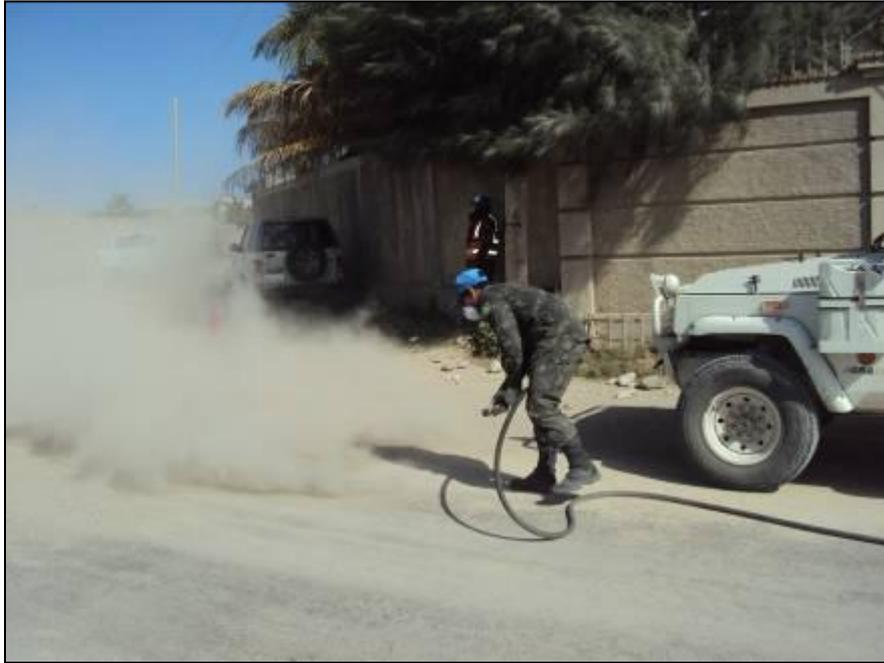
On Wednesday, 27 Jun 12, we used the air compressor to clean the road from side to side, from the beginning to the end, so that the Chief of the MPC could check the results. Mr. Malek went to the worksite in the morning, at around 9:00 a.m.

Picture 14: Cleaning the paved area for verification

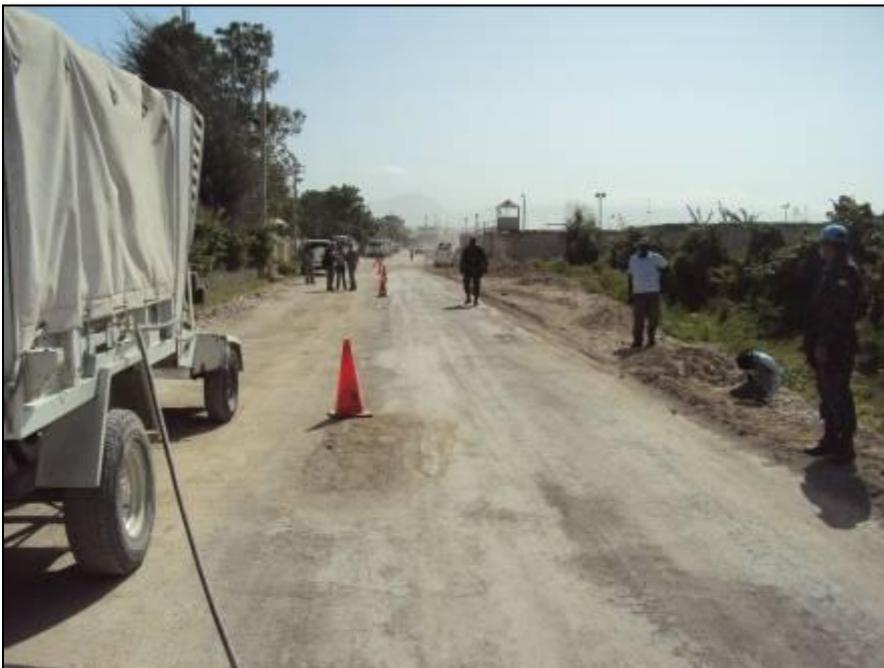
Breaking the water pipe which is under the road caused an excessive humidification of the material deposited. Even under a blazing sun, it is possible to state that the excess of water was responsible for the imperfections on the road. Moreover, the intense traffic of vehicles coming and going out of a residence occupied by the HNP also made it difficult the adequate

Picture 15: The imperfection on the road was caused by the excess of water in front of the HNP.

In order to best support the decision, it is recommended that the performance of the paved area be analyzed as time goes by, mainly in relation to the following aspects: resistance to intense traffic and to weather conditions (esp. downpours).
